Corrosion

OFFICIAL PUBLICATION
NATIONAL ASSOCIATION
OF CORROSION ENGINEERS

SEPTEMBER
1960

No. 9

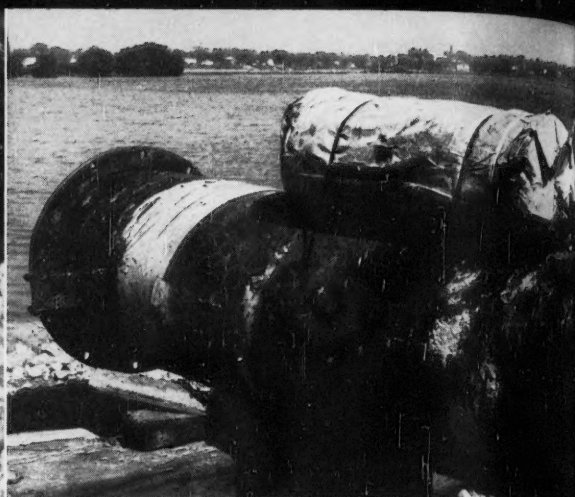
Figure 2—Showing how packaged magnesium anodes were fastened to water line with stainless steel straps.

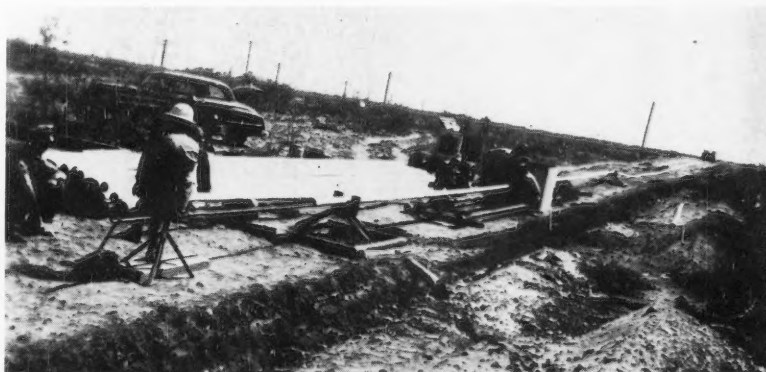
Figure 1—General view of aluminum pipe laying operation. Left to right: stock of aluminum pipe, first set of dollies for supporting pipe at welding station, welding machine, welding station, second set of dollies, and truck dragging section forward along ditch.
